# Drainage Report

Site  
**Lon Cae Darbi**  
**Caernarfon**  
**Wales**

**3220 Gwynedd Skip & plant Hire Drainage AREA 2 - CCTV Survey Report : 02/05/22**

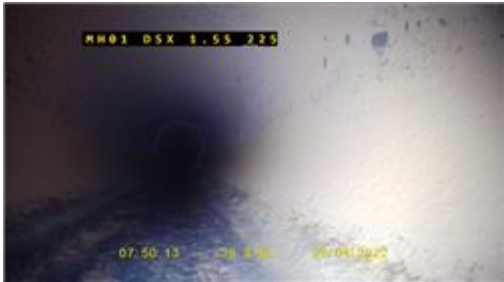
38.81m		MHF	Finish node type, manhole MH04? unable to push camera any further due to distance and size of pipe	Image Provided - Ref: 0_9999

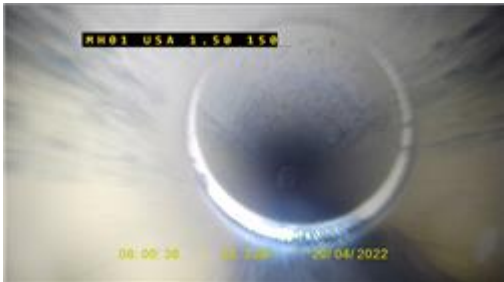
00.00m	0:00:00	WL	Water level: 0% Height/Diameter	
24.33m	0:02:47	JDM	Joint displaced medium - Severity 3	Image Provided - Ref: 1_2

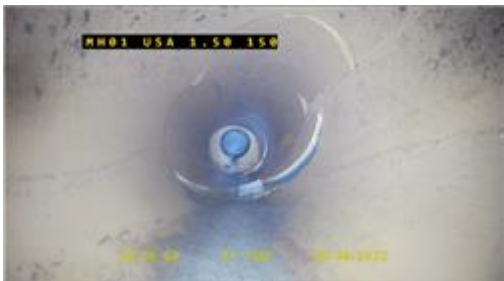
27.15m	0:03:08	CM	Cracks, multiple from 12 o'clock to 12 o'clock - Severity 2	Image Provided - Ref: 1_4

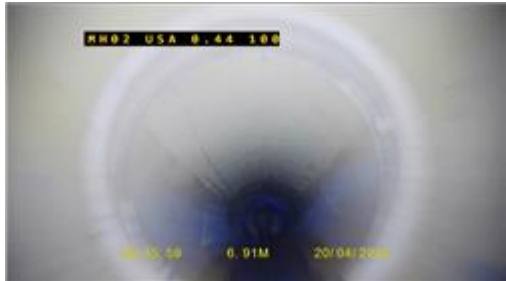
00.00m	0:00:00	WL	Water level: 0% Height/Diameter	
06.91m	0:00:14	LDQ	Line of drain/sewer deviates down [quarter]	Image Provided - Ref: 4_2

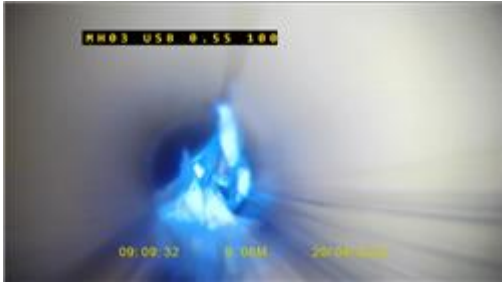
09.06m	0:00:34	OB	Other obstacles: 100% Cross sectional area loss - Severity 3	Image Provided - Ref: 8_3

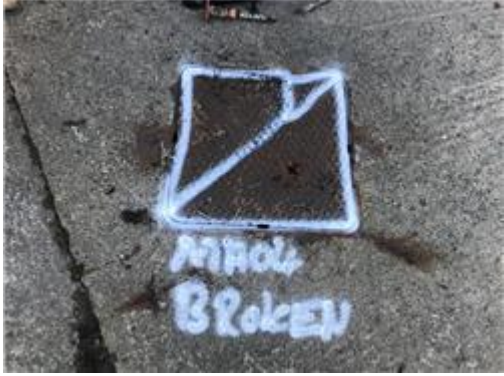
Node Type	Cover Condition	Benching Condition	1/2 Channel Condition	Node Condition Remarks
MH	Inadequate <span style="color: orange;">✗</span>			Manhole Broken

Pos	Video Ref	Code	Description	Image
00.00m		MH	Start node type, manhole MH04	Image Provided - Ref: 9_0

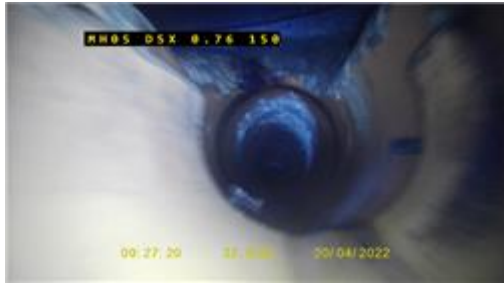
Pos	Video Ref	Code	Description	Image
32.95m	0:01:33	REM	General remark Manhole in side Building	Image Provided - Ref: 10_5

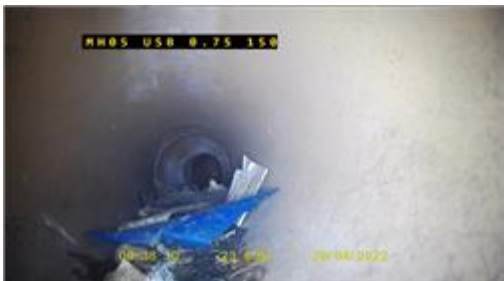
23.60m	0:01:37	DES	Settled deposits fine: 15% Cross sectional area loss - Severity 3	Image Provided - Ref: 12_4

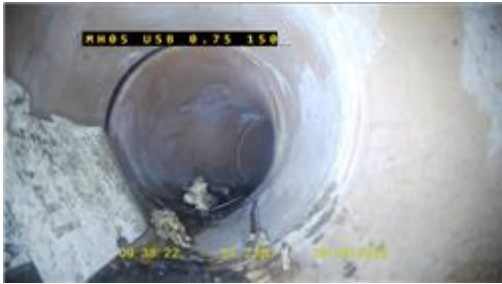
Pos	Video Ref	Code	Description	Image
24.23m	0:01:49	LRQ	Line of drain/sewer deviates right [quarter]	Image Provided - Ref: 12_5

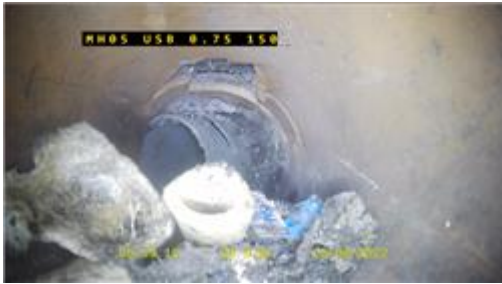
29.97m	0:02:42	CR	Crack, radiates from 12 o'clock - Severity 1	Image Provided - Ref: 12_6

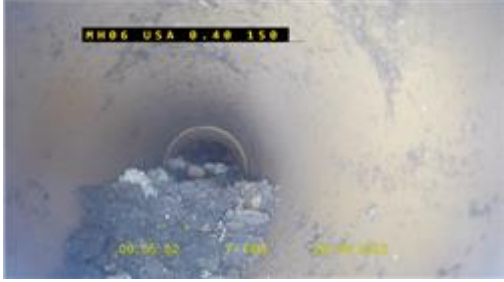
07.14m	0:00:33	DER	Settled deposits coarse: 100% Cross sectional area loss - Severity 3	Image Provided - Ref: 14_3

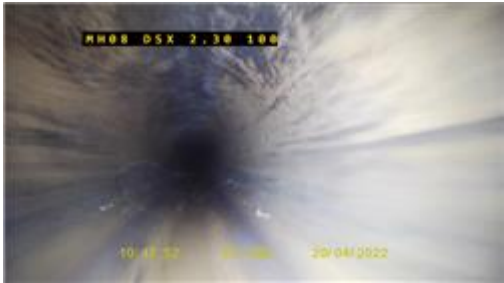
00.00m	0:00:00	WL	Water level: 0% Height/Diameter	
13.75m	0:00:45	CL	Crack, longitudinal at 09 o'clock - Severity 1	Image Provided - Ref: 18_2

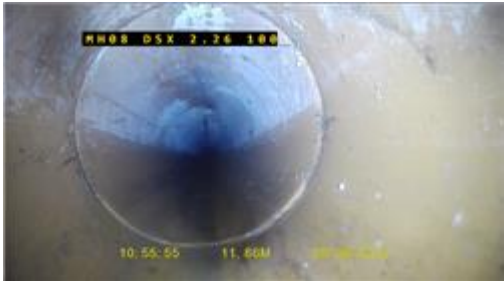
00.00m	0:00:00	WL	Water level: 0% Height/Diameter	
11.90m		MHF	Finish node type, manhole MH07 Camera got stuck for some reason unable to push further	Image Provided - Ref: 19_9999

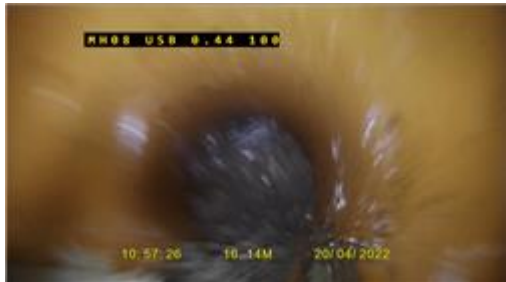
00.00m	0:00:00	WL	Water level: 0% Height/Diameter	
16.14m	0:00:35	OB	Other obstacles: 100% Cross sectional area loss - Severity 3 Blocked	Image Provided - Ref: 20_2
