# Drainage Report

Site  
**Lon Cae Darbi**  
**Caernarfon**  
**Wales**

**3220 Gwynedd Skip & plant Hire Drainage AREA 2 - CCTV Survey Report : 02/05/22**

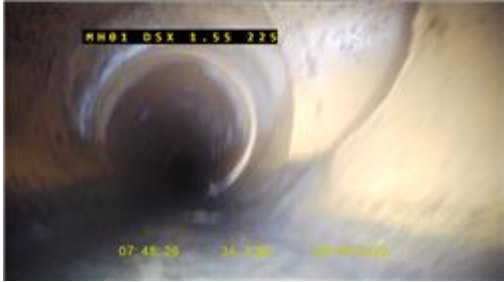
38.81m		MHF	Finish node type, manhole MH04? unable to push camera any further due to distance and size of pipe	Image Provided - Ref: 0_9999

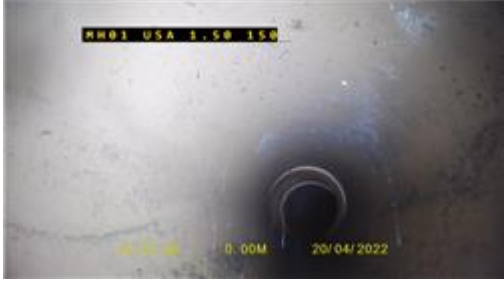
Pos	Video Ref	Code	Description	Image
00.00m		MH	Start node type, manhole MH01	Image Provided - Ref: 1_0

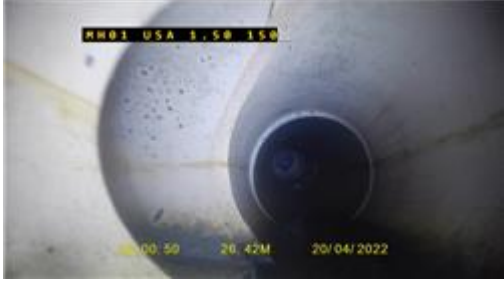
26.42m	0:03:00	JN	Junction at 09 o'clock: 100mm Diameter	Image Provided - Ref: 1_3

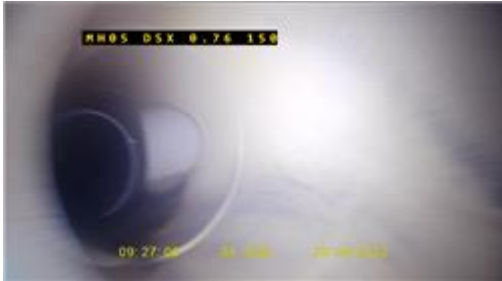
30.55m	0:01:19	LLH	Line of drain/sewer deviates left [half]	Image Provided - Ref: 10_3

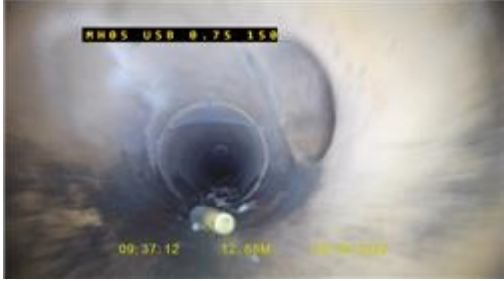
23.60m	0:01:37	DES	Settled deposits fine: 15% Cross sectional area loss - Severity 3	Image Provided - Ref: 12_4

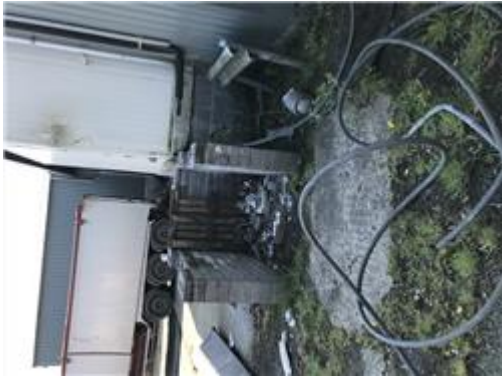
30.00m		GYF	Finish node type Gully	Image Provided - Ref: 12_9999

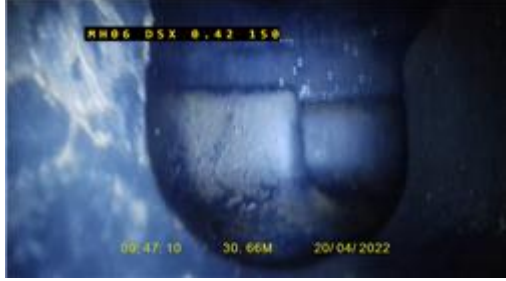
30.66m		MHF	Finish node type, manhole MH07	Image Provided - Ref: 13_9999

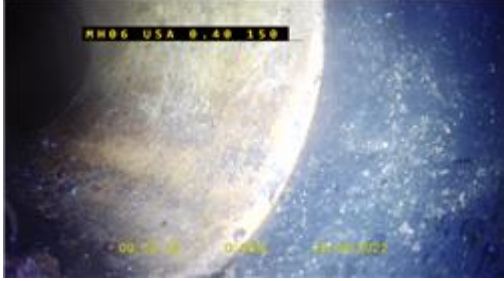
Pos	Video Ref	Code	Description	Image
00.00m		MH	Start node type, manhole MH06	Image Provided - Ref: 14_0

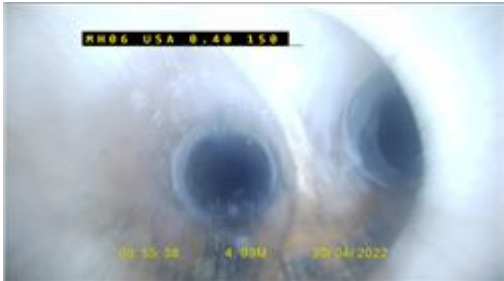
00.00m	0:00:00	WL	Water level: 0% Height/Diameter	
04.99m	0:00:19	JN	Junction at 03 o'clock: 100mm Diameter	Image Provided - Ref: 14_2

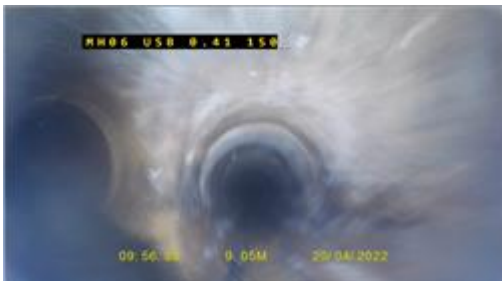
09.05m	0:00:19	JN	Junction at 09 o'clock: 100mm Diameter	Image Provided - Ref: 15_5

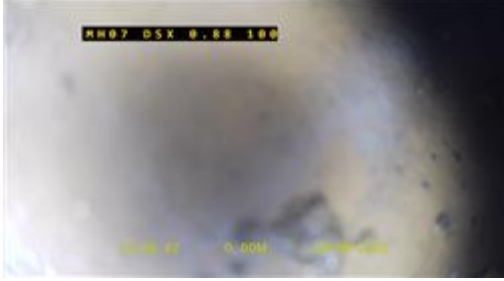
Pos	Video Ref	Code	Description	Image
00.00m		MH	Start node type, manhole MH07	Image Provided - Ref: 16_0

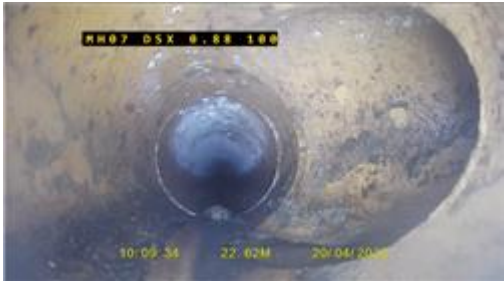
00.00m	0:00:00	WL	Water level: 0% Height/Diameter	
22.62m	0:00:52	JN	Junction at 03 o'clock: 100mm Diameter	Image Provided - Ref: 16_2

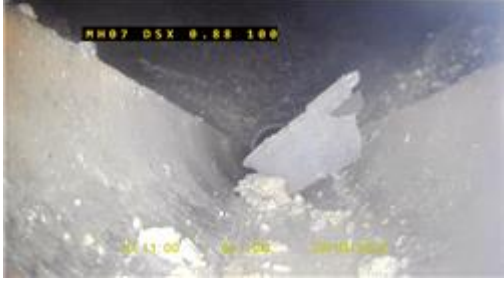
45.15m		MHF	Finish node type, manhole MH08	Image Provided - Ref: 16_9999

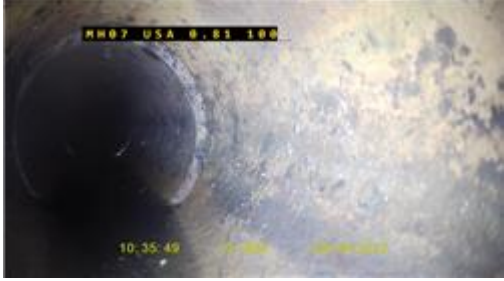
Pos	Video Ref	Code	Description	Image
00.00m		MH	Start node type, manhole MH07	Image Provided - Ref: 17_0

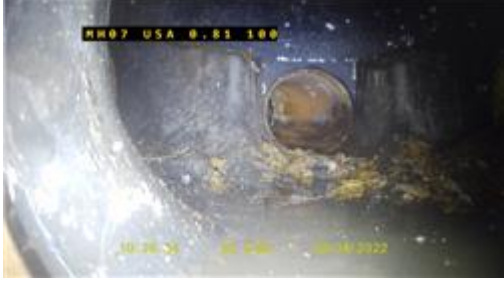
30.54m		MHF	Finish node type, manhole MH06	Image Provided - Ref: 17_9999

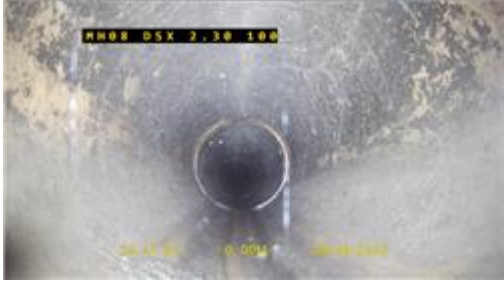
Pos	Video Ref	Code	Description	Image
00.00m		MH	Start node type, manhole MH08	Image Provided - Ref: 18_0

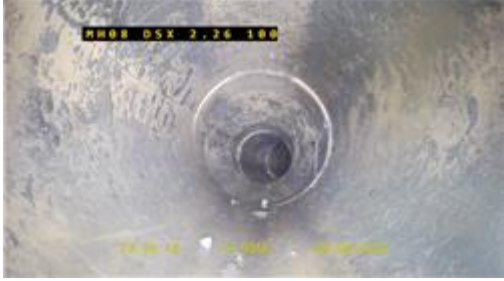
Pos	Video Ref	Code	Description	Image
00.00m		MH	Start node type, manhole MH08	Image Provided - Ref: 19_0

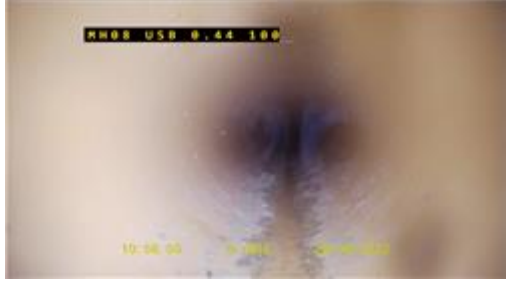
Pos	Video Ref	Code	Description	Image
00.00m		MH	Start node type, manhole MH08	Image Provided - Ref: 20_0
